Dredging Research Technical Notes

Field Evaluation of Endeco Model 1029 Tide Gage

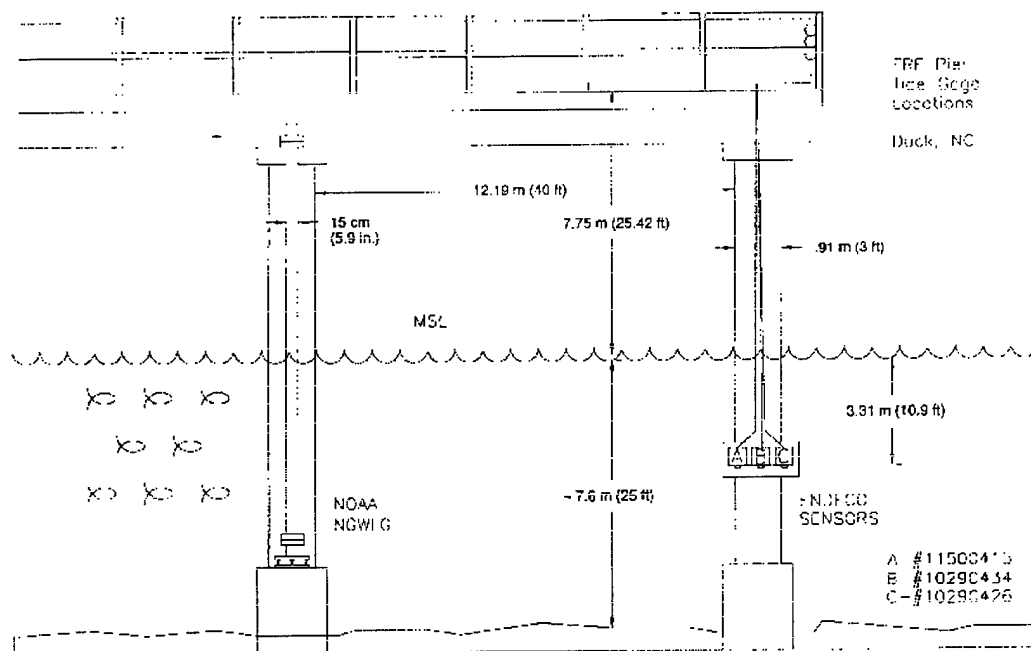
Figure 1. Diagram showing sensor location on pier

The Endeco gage sensors were oriented vertically and mounted side by side on a single flat plate. The plate was then installed on the pier support piling (Figure 1) and leveled. Care was taken to ensure that all three sensors were at the same vertical level. Measurements from the top of the pier to the bottom of the sensor housings indicated that the sensors were 3.3 m (10.8 ft) below National Geodetic Vertical Datum (NGVD). Both Endeco and NOAA data were adjusted to NGVD to allow a direct comparison.
